INDOOR AIR QUALITY ASSESSMENT

Marshall Simonds Middle School 114 Winn Street Burlington, MA 01803

Prepared by:
Massachusetts Department of Public Health
Center for Environmental Health
Emergency Response/Indoor Air Quality Program
May 2005

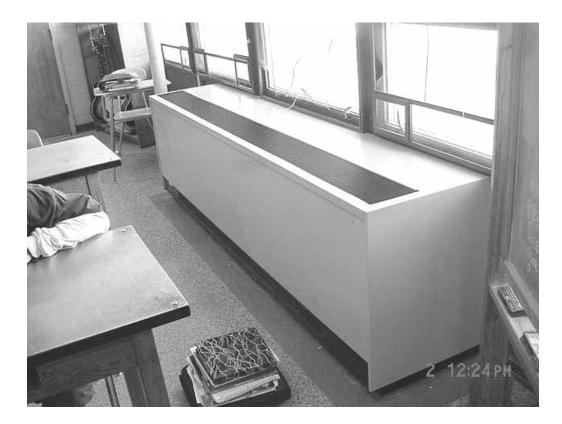
Classroom Univent

- 1. Continue working with HVAC engineering firm for options to increase the introduction of outside air to occupied areas.
- 2. Operate all ventilation systems that are operable throughout the building (e.g., gym, auditorium, classrooms) continuously during periods of school occupancy and independent of thermostat control. To increase airflow in classrooms, set univent controls to "high".

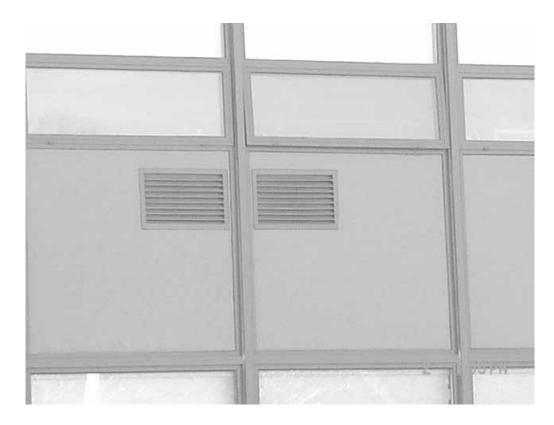
Univent Air Intakes

- 6. Remove all blockages from univents and exhaust vents to ensure adequate airflow.
- 7. Develop a notification system for building occupants to report ventilation/comfort complaints.

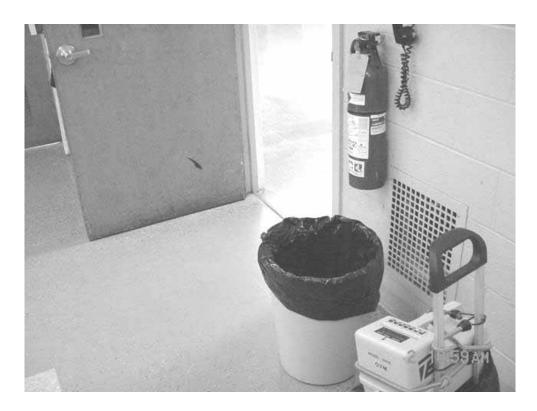
Exhaust ventilation in classrooms is provided by ducted, grated wall vents (Picture 3) powered by rooftop motors (Picture 4). At the time of the assessment, several exhaust vents were off and/or obstructed (Picture 5). As with the univents, in order to function properly, exhaust vents must be activated and remain free of obstructions. In addition, the location of some exhaust vents can limit exhaust efficiency. In several rooms, exhaust vents are located near hallway doors. When classroom doors are open, these exhaust vents become blocked (Picture 3). Exhaust vents in these rooms will also tend to draw air from both the hallway and the classroom reducing the effectiveness of the exhaust vent to remove common environmental pollutants.

Classroom Exhaust Vent, Note Proximity to Open Hallway Door

- 3. Inspect exhaust motors and belts for proper function. Repair and replace as necessary.
- 4. Close classroom doors to maximize exhaust function.
- 5. Use openable windows to facilitate air exchange.

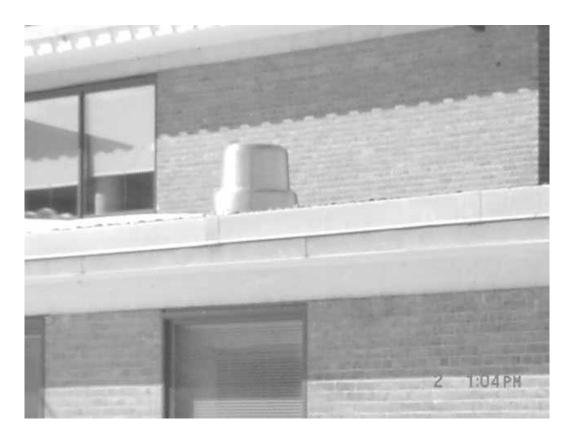
Rooftop Exhaust Motor

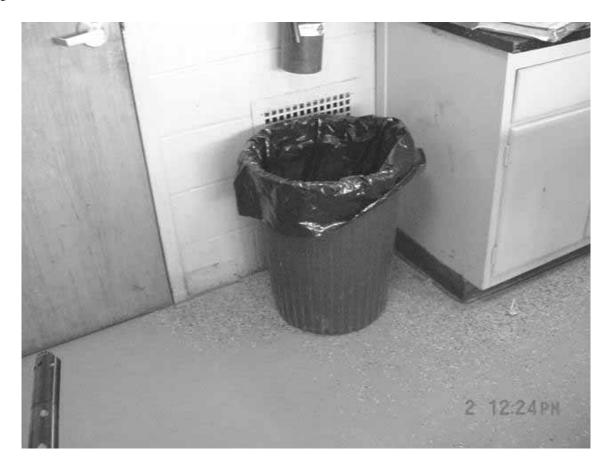
Classroom Exhaust Vent Obstructed by Trash Barrel

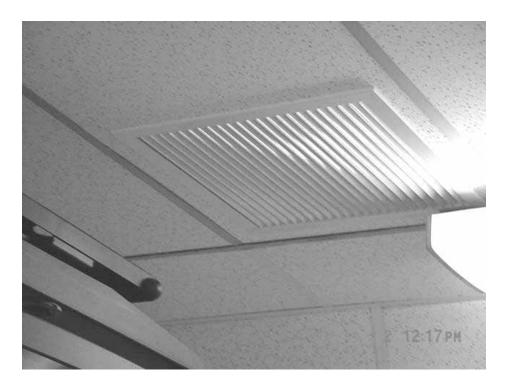
Mechanical ventilation in the main office and common areas such as the gymnasium and auditorium is provided by rooftop air-handling units (AHUs) connected to ceiling or wall-mounted air diffusers via ductwork (Picture 6). Return air is drawn into wall or ceiling exhaust vents, which are ducted back to the AHUs. The majority of these systems were functioning during the assessment. Because of the location of supply and

Ceiling-Mounted Return Vent

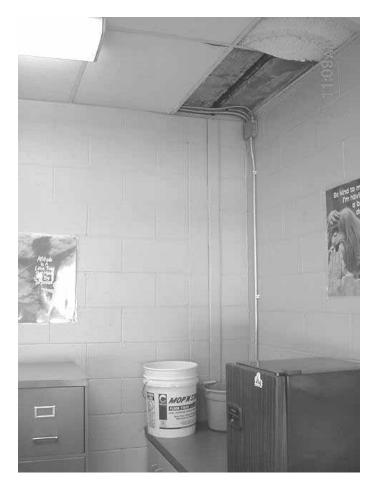
Several areas had water-damaged ceiling tiles, which can indicate leaks from the roof or plumbing system (Pictures 7 and 8/Table 1). Occupants in the Tutor's room reported periodic leaks, which are the result of faulty flashing according to BSD staff. Repeated water damage to porous building materials (e.g., wallboard, ceiling tiles, carpet) can result in microbial growth. Water-damaged ceiling tiles can provide a source of mold and should be replaced after a water leak is discovered and repaired. The US Environmental Protection Agency (US EPA) and the American Conference of Governmental Industrial Hygienists (ACGIH) recommend that porous materials be dried with fans and heating within 24 to 48 hours of becoming wet (US EPA, 2001; ACGIH, 1989). If porous materials are not dried within this time frame, mold growth may occur.

Active Roof Leak in Tutor's Room, Note Missing Tile and Bucket

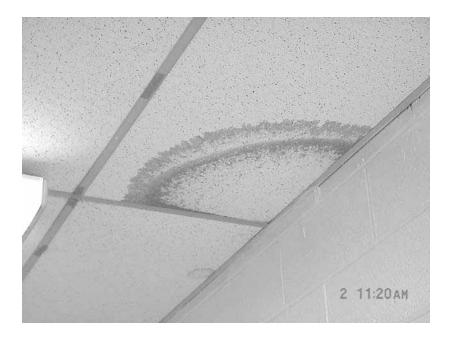
Water Damaged Ceiling Tile in Classroom

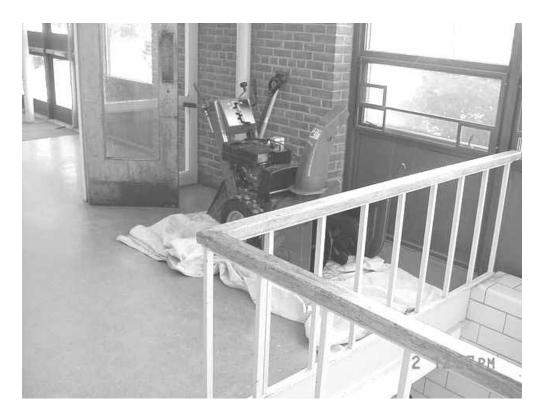
Snow-Blower Stored in Hallway Outside Gymnasium

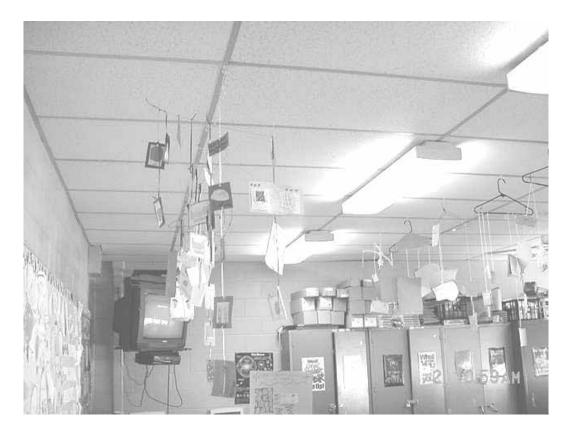
Items hanging from ceiling tiles were seen in several classrooms (Picture 10). Classrooms in a number of areas also had missing, damaged or dislodged ceiling tiles. The absence or movement of ceiling tiles can allow for accumulated dirt and dust from the ceiling plenum into occupied areas. A number of exhaust/return vents were noted with accumulated dust. If exhaust vents are not functioning, backdrafting can occur, which can re-aerosolize accumulated dust particles.

Items Hanging Form Ceiling Tiles in Classroom
